Subject : Free play in automatic elevator hook-up, adjustment

Effectivity type: DG-800
variants: all

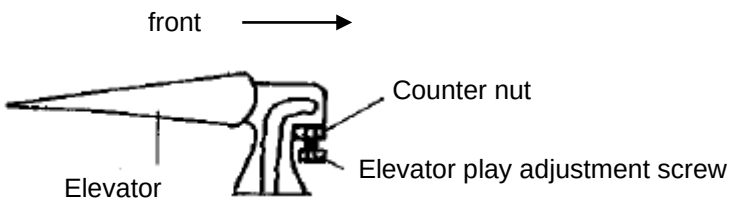
Figure 1, schematical view of elevator

Reason : On a DG-300, the rod end at the upper end of the elevator pushrod in the fin broke off at the thread.
It was found that the elevator play adjustment screw was turned in too far, which caused jamming of the roller inside the funnel. The roller couldn´t be moved up to the front of the funnel, even with higher force.

Thereby each time when rigging and during operation a bending force acted on the rod end, which caused failure of the rod end with time.
As the type of automatic elevator hook-up is similar in all DGs equipped with automatic hook-up, the following instructions are valid for all affected DG gliders and motor gliders.

2. Check of the free play adjustment of the automatic elevator hook-up.
2.1 For this step, one of three alternative methods can be chosen, method a), b) or c):

a), b) and c) Now enter the roller (at the rod end or on the pin) into the funnel at the elevator and slide it around the corner (horizontal tailplane not rigged to glider). Now move the roller completely to the front. If the roller can´t be moved without force completely to

the front, this is an indication the glider was operated with the adjustment screw turned in too far, see instruction 2.2. In this case, turn back the adjustment screw and bend back the sheet metal in the funnel, which was bent by the adjustment screw. Then adjust the free play again and tighten the counter nut.

2.2 In case the glider was operated with the adjustment screw turned in too far (see instruction 2.1), the rod end must be replaced by a new one 8St50/1.
If a new rod end is needed, order it immediately at DG.
Mark the removed rod end as unserviceable part.
