Technical Note No. 1000/50

Subject : Free play in automatic elevator hook-up, adjustment

Effectivity type: DG-1000
variants: all

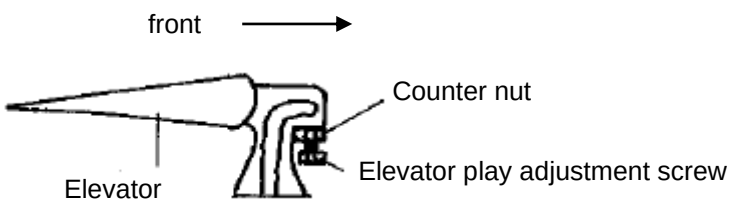
Figure 1, schematical view of elevator

Reason : On a DG-300, the rod end at the upper end of the elevator pushrod in the fin broke off at the thread.
It was found that the adjustment screw was turned in too far, which caused jamming of the roller inside the funnel. The roller couldn´t be moved up to the front of the funnel, even with higher force.

Thereby each time when rigging and during operation a bending force acted on the rod end, which caused failure of the rod end with time.
As the type of automatic elevator hook-up is similar in all DGs equipped with automatic hook-up, the following instructions are valid for all affected DG gliders and motor gliders.

front, this is an indication the glider was operated with the adjustment screw turned in too far, see instruction 2.2. In this case, turn back the adjustment screw and bend back the sheet metal in the funnel, which was bent by the adjustment screw. Then adjust the free play again and tighten the counter nut.

2.2 In case the glider was operated with the adjustment screw turned in too far (see instruction 2.1), the rod end must be replaced by a new one 10St97/1.
If a new rod end is needed, order it immediately at DG.
Mark the removed rod end as unserviceable part.
