DG Flugzeugbau GmbH
76646 Bruchsal

Service Info
No. 55-04

Subject : Landing gear control – side cover in rear cockpit

Effectivity : DG-1000S, all ser. no.'s

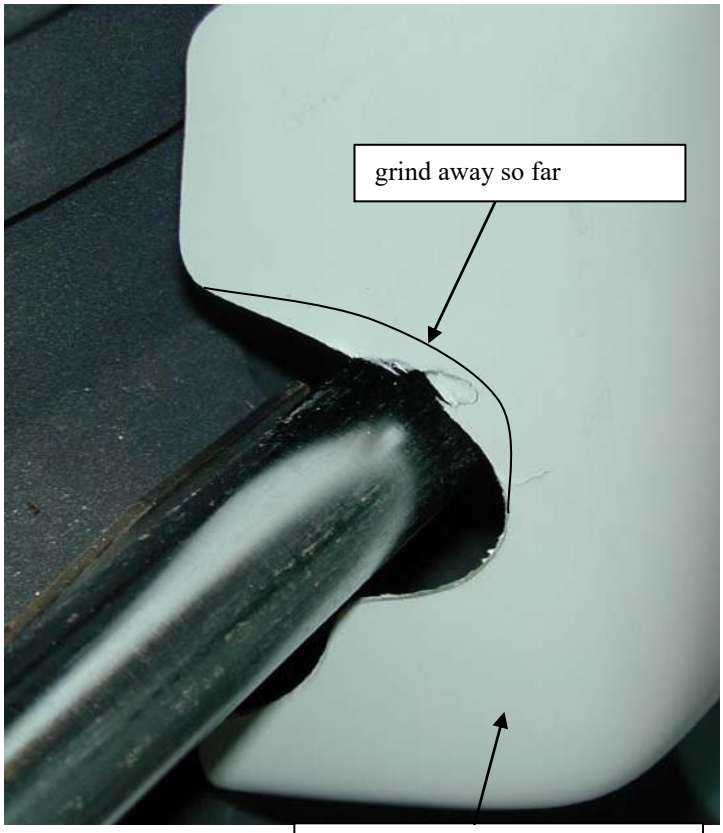
side cover in rear cockpit left hand side, front part

Reason : If the landing gear operating handle is rotated very far into the cockpit, the locking latch at the push rod may interfere with the side cover.

Instructions : Extend the landing gear so far, that the locking latch is located directly at the side cover. Rotate the operating handle and mark it's position on the side cover. Remove the side cover and grind away so much, that the locking latch has 3mm clearance in it's most unfavourable position, see sketch.
